**ANALYSIS AND EVALUATION OF FLEXIBLE PAVEMENT DEFECTS****SATYA PAL SINGH¹**

According to the research, the flexible pavement defects and its causes has been defined in terms of decrease in serviceability which was due to the development of different types of deteriorations like cracks, surface defects, disintegration etc. on the flexible pavement. Before going into the maintenance part, we will try to focus on the various defects and its causes. There are so many reasons for bituminous pavement failures. The level of correction in the existing surface will extend the life of maintenance works and strengthening the layer as well. According to my study, there are mainly 2 parameters I have figured out which are: - *pavement cracking* and surface defects on the pavement. While other distresses have been excluded including these parameters while stepping for maintenance part. With the study of maintenance techniques, there are various methods we are going to adopting for pavement protection which will help to increasing the life of the pavement and failure delay. The motive of this study was to analyse and evaluate the various causes of pavement defects, and provision of remedies to

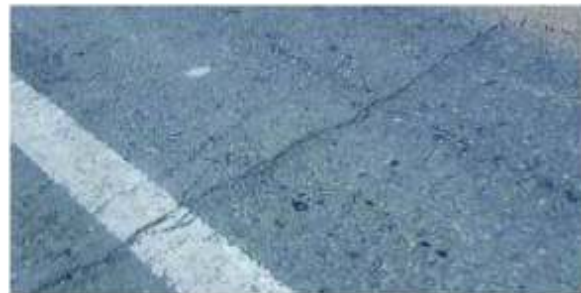
Figure 1: Longitudinal cracks

Transverse Cracks

These cracks are non-connected cracks which are formed perpendicular to the direction of the pavement.

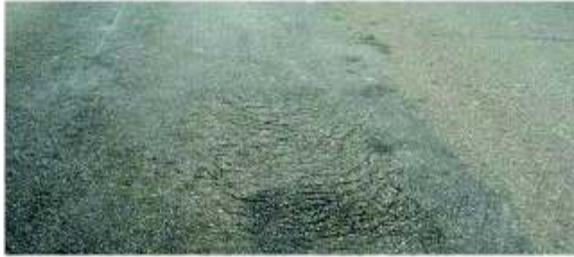
Figure 3: Slippage Cracks

Slippage Cracks

These are formed like crescent or horseshoe shape which are generally formed due to braking of the vehicles. Mostly these type of cracks shows on intersections due to stopping.

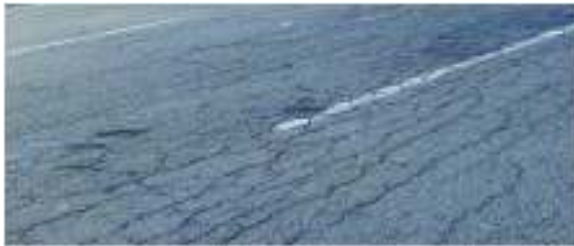
Figure 4: Alligator Cracks

Alligator Cracks

It is the series of interconnected cracks which are caused by fatigue failures. These are normally called as crocodile cracks. These interconnected cracks can be called as cells. Each cell size may go larger than 300 mm.

- b) Pavement condition Index (PCI) was found out to know the condition of the pavement according to its distress sheet as per severity level from ASTM-D6433. From the method of pavement condition index, we got to know the condition of the pavement of overall section which was coming out to be “Fair” by the rating. The reason of having high severity level was caused by alligator cracks.

- d) Proper designing of flexible pavement is utmost importance for the major causes of defects. Since, the major causes of deterioration are due to alligator cracks which were arise due to cycling action of loading.

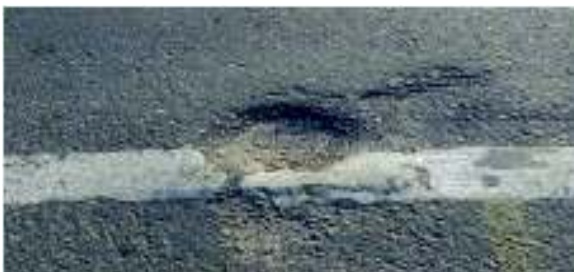
Figure 5: Potholes

Potholes

These are small bowl-shaped holes formed on the pavement. They have sharp corners and vertical sides near the top of the hole.

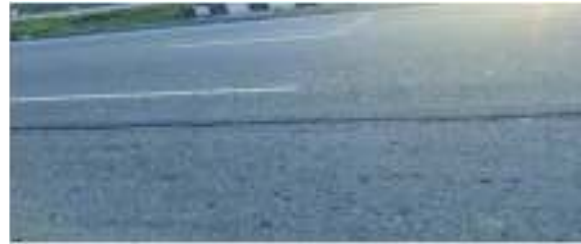
Figure 6: Longitudinal Cracks

Longitudinal Cracks

These are the long, straight cracks and formed parallel to the centre of the pavement. This could be occurred due to joint failure or frost heaving.

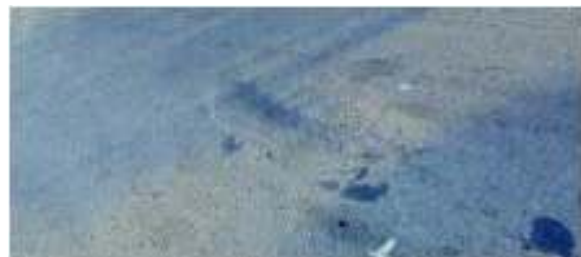
Figure 7: Swelling

Swelling

It is the upward budge in the pavement surface. Generally, it is caused by moisture due to expansion. Swelling is caused by expansion in the supporting layer of the pavement.

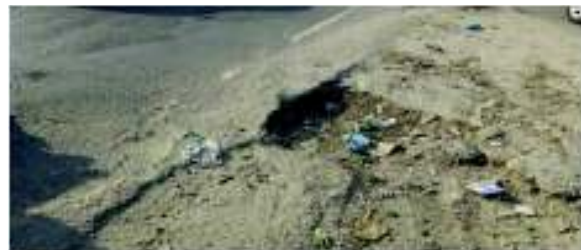
Figure 8: Edge cracking and shoulder drop off

Edge Cracking and Shoulder Drop Off

The type of cracking starts from edge of the pavement which may leads to alligator cracks after some days. The main causes of this type of defects are weak bases of the soil. Shoulder drop off of the pavement is caused by weak edges of the pavement.

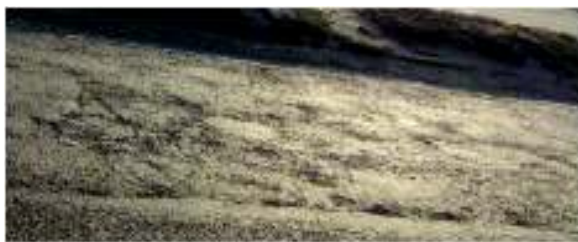
Figure 9: Weathering and ravelling

Weathering and Ravelling

It is the adhesion between the asphalt cement and aggregate. Deformation starts with breaking up of fine aggregates in small pieces and leaves small patches over the pavement and leaves rough surface.
